# Manhole Inspection Summary

Manhole # S33Q1\_003MH

Insp Date: **4/7/08 9:46 AM**

**Location** Address: **701 Cherryland Rd. (in the woods east of Reedbird)** Cross Street: **Reedbird Ave.**

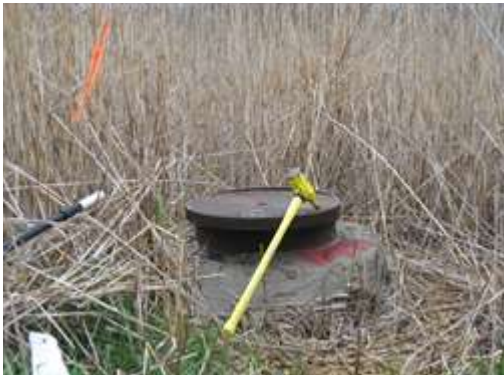
Location View

701 Cherryland Rd. (in the woods)

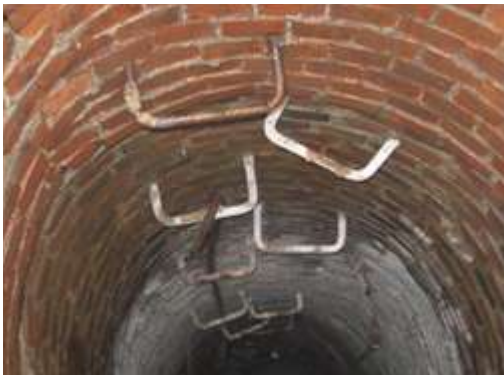
Steps

**Steps** Count: **14** Missing: **1** ☐ Corroded

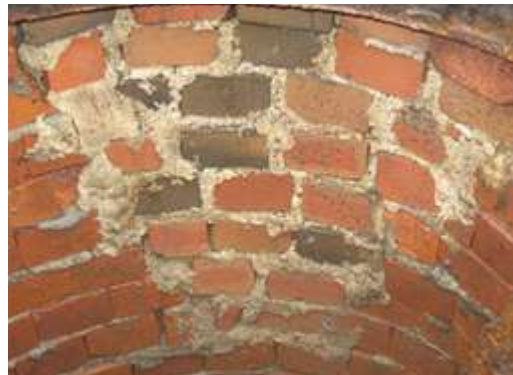
Defect 2

**Chimney / Frame Adjustment** ☒ Exists Material: **Brick** ☐ Parged Height: **26** (in.)  
Condition: ☒ Sound ☐ Cracked ☐ Root Intrusion ☐ Loose Brick ☐ Deteriorated  
Infiltration: ☐ None ☒ **Joint** ☐ Cracks ☒ **Mortar** ☐ Roots ☐ Wall

Mortar

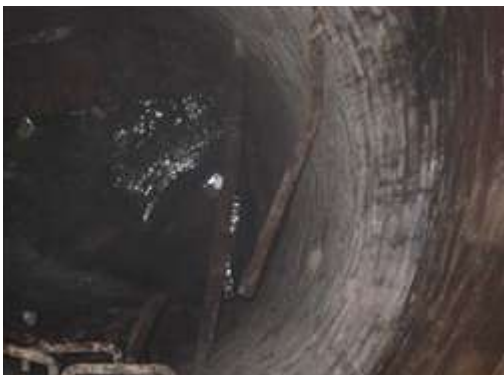
Defect 1

**Channel** Material: **Brick** ☐ Parged  
Channel Exposure: **Partially Open** Junc Dist: **0** nearest .5 ft. Azimuth:  
Condition: ☐ Sound ☐ Cracked ☐ Root Intrusion ☐ Deteriorated ☐ Leaks ☒ **Debris**

Poles and Debris

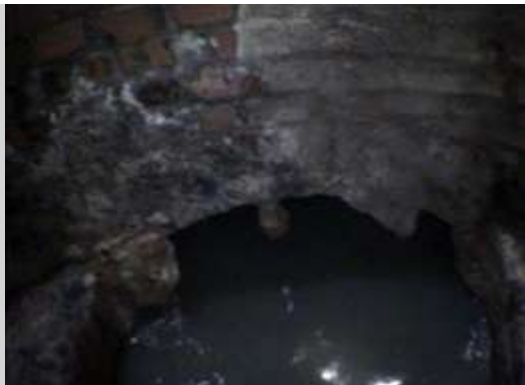
6 O'Clock Inflow

33 in. Circular Gravity Sewer  
Pipe In @ 6 O'Clock

Pipe Height: **30** (in.) Rod and Bar (Angled)  
Pipe Material: **Clay** ☐ Pipe Lined  
Invert Depth: **25.40** (ft.) Flow Characteristics: **Fast**  
Deposits: ☒ None ☐ Mud ☐ Sludge ☐ Debris ☐ Grease  
Silt Depth: (in.) Deposits Extent:  
Infiltration: **None** Pipe Seal Cond: **Sound**
